Site Effects and Damage Patterns

A set of observations on site effects and damage patterns from the M_w 8.8 Maule, Chile, earthquake is presented, focusing on identification of structural damage variability associated with nonuniform soil conditions and subsurface geology. Observations are reported from: (1) the City of Santiago de Chile (Américo Vespucio Norte Ring Highway, Ciudad Empresarial business park), (2) the Municipality of Viña del Mar, and (3) the City of Concepción, extending over 600 km along the Chilean coast. Reconnaissance information and ground motion recordings from the megathrust event are combined with site investigation data in the regions of interest. Comparisons against macroseismic observations related to uneven damage distribution from the M_w 8.0 1985 Valparaíso earthquake are discussed. Complexities associated with identifying the mechanics and underlying physical processes responsible for the manifestation of these effects are elucidated. [DOI: 10.1193/1.4000029]

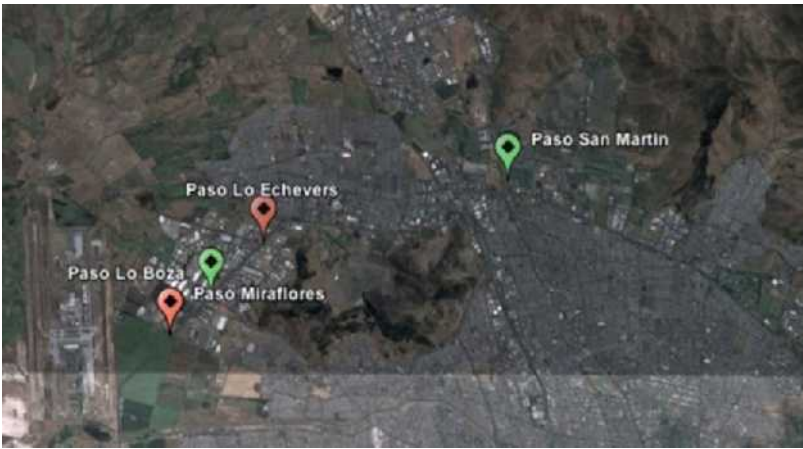
Four bridge sites were inspected along Américo Vespucio Norte, the 29 km-long northern section of Santiago’s ring road constructed during the period of 2003 to 2006. The locations of the overpasses are depicted in Figure 2. The damage intensity was highly variable, with two bridges partially collapsing due to unseating (Paso Miraflores and Paso Lo Echevers) and two experiencing only minor structural damage, such as shear key cracking (Paso San Martin and Paso Lo Boza).

Figure 2. Four Américo Vespucio Ring Road bridges visited during the reconnaissance.

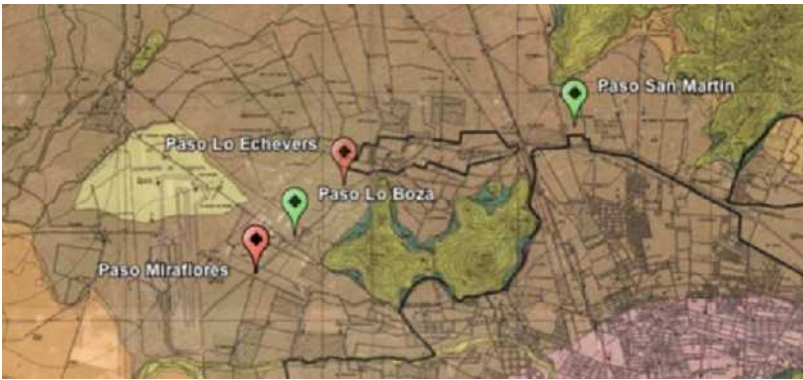
Investigating potential correlation between the bridge damage patterns and the underlying soil conditions, the locations of the four inspected bridges are depicted on a geology map of the Santiago Metropolitan Area in Figure 3. The soil conditions at the four bridge sites appear to be similar, characterized by silts and clays of high plasticity, horizontally stratified

Figure 3. Location of the four bridge sites on the geology map of Santiago Metropolitan Area (Ledezma 2011; approximate map overlay on Google Earth).

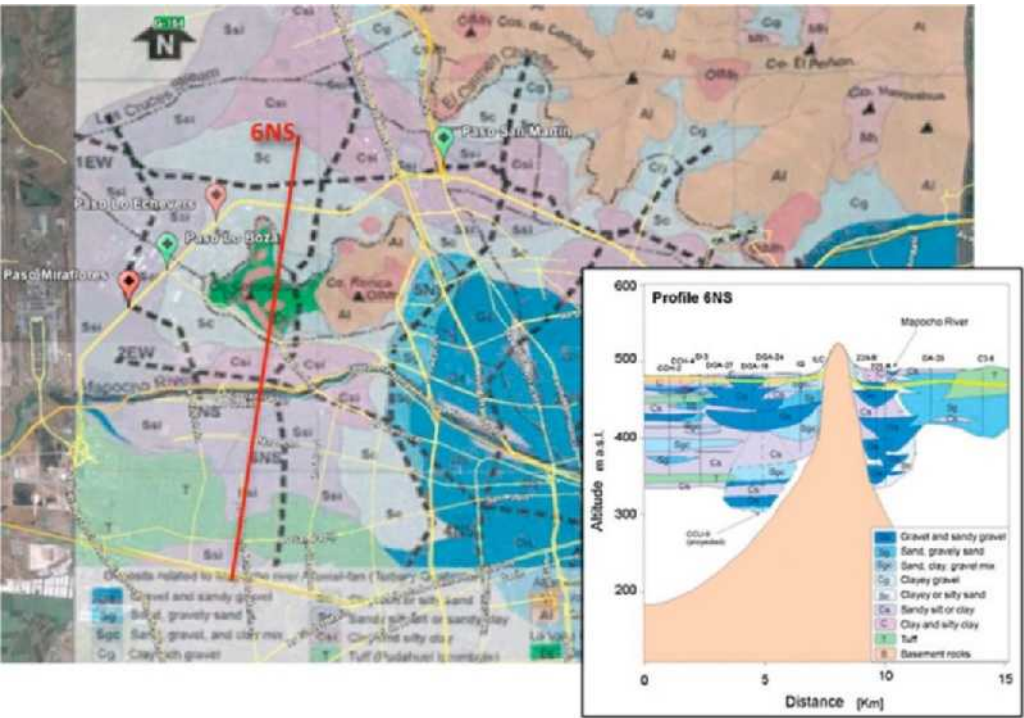
as thin interchangeable layers, a soil formation referred to as *Finos del Noroeste*. According to the NEHRP soil classification system (IBC 2006), the site conditions correspond to Class C or Class D. Figure 4 depicts the locations of the bridge sites on the geological map by Iriarte-Díaz (2003), along with typical NS cross section of the valley geology. The depth to bedrock-basement at the bridge sites, as approximately interpreted from the cross section, does not show clear correlation with the damage states.

Figure 4. Location of the four bridge sites on the map of geological cross-sections in the North-Western part of Santiago de Chile; and geological cross-section along profile 6NS (Iriarte-Diaz, 2003). Paso San Martin (minor damage) is located on clay/silty clay, Paso Lo Echevers (partially collapsed) on clay/silty sand, and Paso Lo Boza (minor damage) and Paso Miraflores (partially collapsed) on sandy silt or silt.

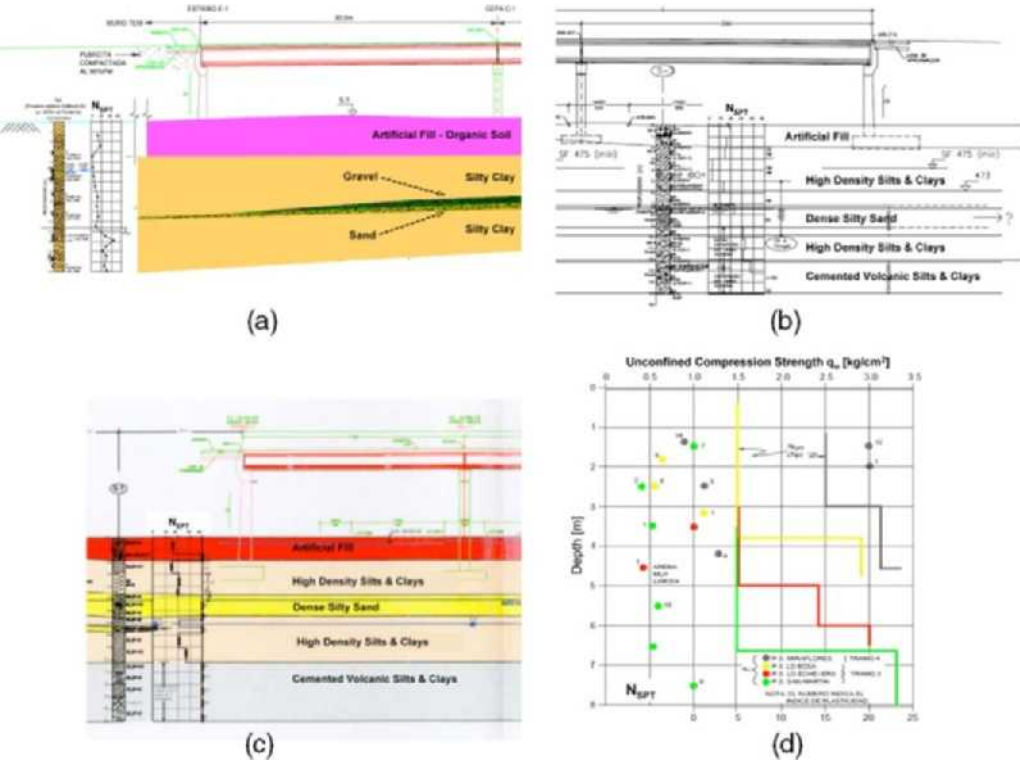
foundation distress. According to the local geology map, the soil profile at the site is clay and silty clay. Similarly, Paso Lo Boza (33.3865°S, 70.7601°W) suffered minor damage, comprising primarily of shear key failure and subsequent displacement of the deck in the transverse direction (see Figure 7). According to the local geology map, the soil profile at the site is sandy silt. On the other hand, Paso Superior Lo Echevers (33.3759°S, 70.7476°W) and Paso Miraflores (33.3945°S, 70.7700°W) suffered severe damage, including collapse of the highway deck (see Figures 6 and 8), while founded on soils very similar to the ones described above, namely clayey/silty sand at the former and sandy silt at the latter. Site-specific geotechnical data collected at the locations of the four bridges that were inspected during reconnaissance are shown in Figure 9. More specifically, detailed soil profiles are depicted for Paso San Martin (Figure 9a), Paso Lo Echevers (Figure 9b), and Paso Miraflores (Figure 9c), while SPT blow counts and unconfined compression strength (q_u) data at the four locations are compared in Figure 9d.

Figure 9. (a) Soil conditions at Paso San Martin (33.3660°S, 70.6891°W), see Figure 5; (b) soil conditions at Paso Superior Lo Echevers (33.3759°S, 70.7476°W), see Figure 6; (c) soil conditions at Paso Miraflores (33.3945°S, 70.7700°W), see Figure 8; and (d) comparison of geotechnical site investigation data at the four overpass locations. Grey: Paso Miraflores (collapsed), Yellow: Paso Lo Bosa, Red: Paso Lo Echevers (collapsed), and Green: Paso San Martin.

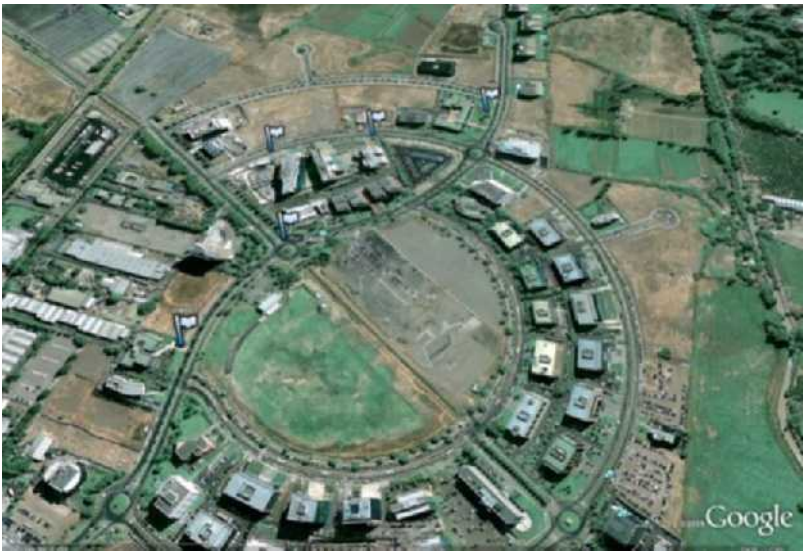
Overall, the business park was severely damaged, with 7 buildings that failed and were closed to the public. No total collapse was documented and no casualties were reported at the site, while the only surface evidence of soil deformation observed at the site is shown in Figure 11b. The damaged structures ranged from 5- to 12-stories high, which to first approximation corresponds to 0.5–1.2 sec resonant periods (0.8–2 Hz). To investigate the potential

Figure 10. Aerial view of Ciudad Empresarial, depicting the structures that were inspected during reconnaissance.

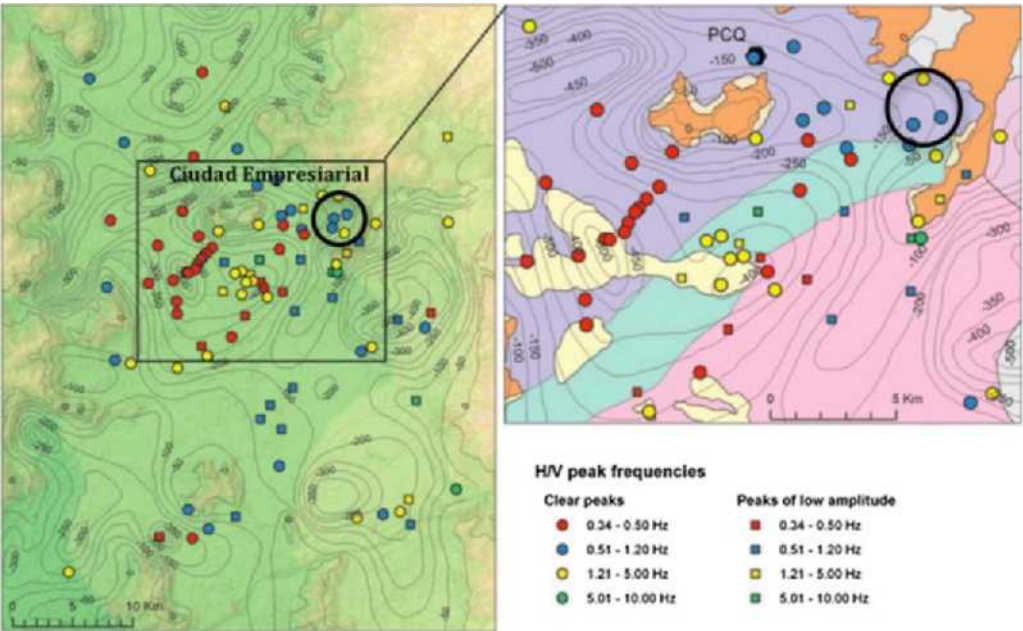
Bonnefoy et al. (2008) conducted extensive ambient vibration measurements in the basin of Santiago, Chile, evaluating the reliability of the horizontal-to-vertical amplitude spectra ratio method (H/V) as a tool to provide qualitative and quantitative information of site conditions in complex geological media. Results from this study showing the spatial distribution of the H/V peaks according to their frequencies are depicted in Figure 13: (red) 0.3–0.5, (blue) 0.51–1.2, (yellow) 1.21–5 and (green) 5.1–10 Hz. Circles display frequencies for clear peaked H/V curves, whereas squares depict frequencies for peaks of low amplitude. The surface geology is shown in the background, while the black circle corresponds to the location of Ciudad Empresarial. As can be readily seen, the resonant frequencies at the site of the business park identified by means of H/V ratios range from 0.5–5 Hz, consistent with the structural resonant periods of the damaged structures. This is an indication

Figure 13. Spatial distribution of H/V peaks from ambient noise measurements in NE Santiago, denoted according to their frequencies: (red) 0.3–0.5 Hz, (blue) 0.51–1.2 Hz, (yellow) 1.21–5 Hz, and (green) 5.1–10 Hz (after Bonnefoy et al. 2008). Black circle corresponds to Ciudad Empresarial.

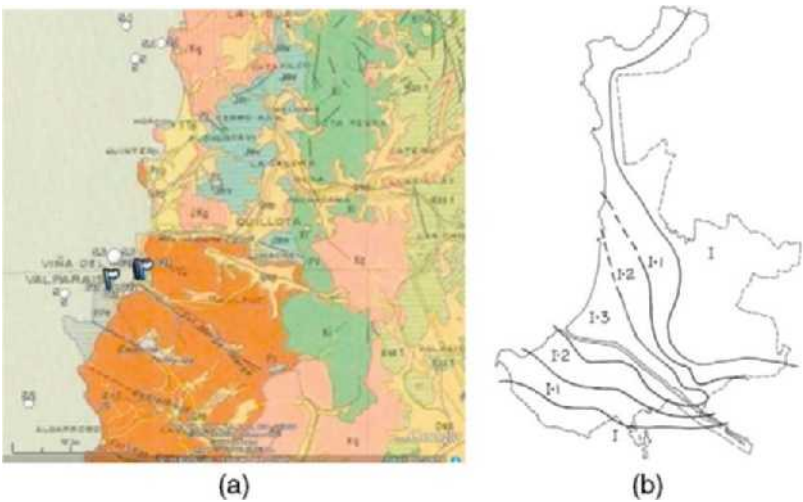
Figure 14. (a) Geology of the Viña del Mar/Valparaíso region, where the site conditions are described as weathered rock; (b) anticipated Modified Mercalli Intensity in the town of Viña Del Mar based on the river sediment geomorphology in the area (Moehle et al. 1986).

$I + 1$ and $I + 2$ on the slopes leading down to the city and $I + 3$ in the alluvial, fluvial, and colluvial deposits along the Marga-Marga River (Figure 14b).

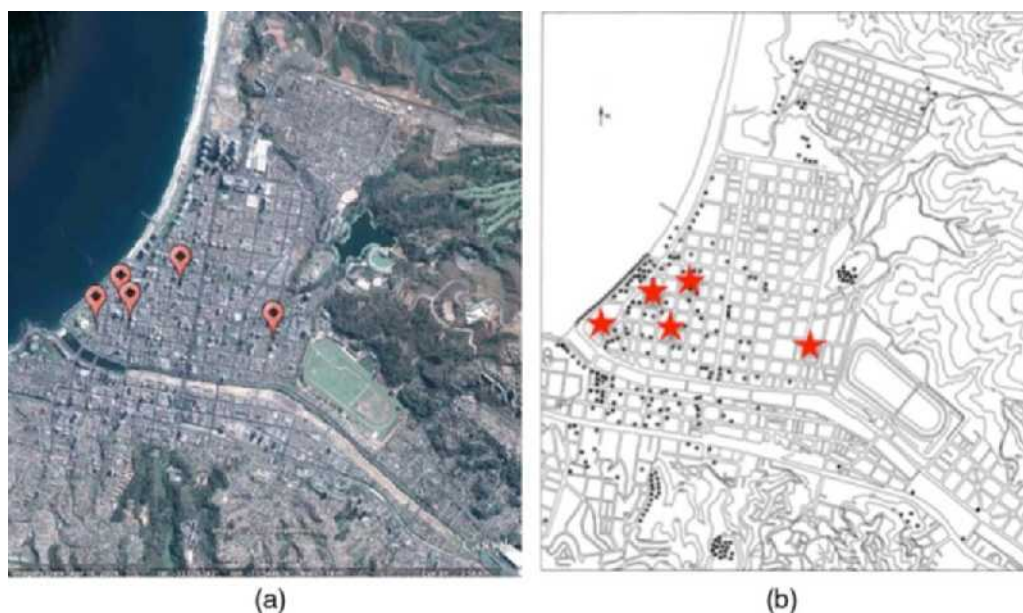
Figure 15. (a) Buildings inspected during reconnaissance in Viña del Mar. (b) Damaged buildings of five stories or higher, as mapped during microzonation study that followed the 1985 Valparaíso Earthquake (from Moehle et al. 1986). Note the similar concentration of damage in the southern part of the city, near the Marga-Marga river mouth in the two events.

Indeed, the same damage pattern was observed during reconnaissance of the 2010 event. Five severely damaged buildings were inspected, all located in the vicinity of the Marga-Marga river mouth and thus founded on soft soil conditions. Note that during the microzonation study following the 1985 Earthquake, the Municipality of Viña del Mar mapped the location of buildings with 5 or more stories (Figure 15). The buildings inspected during reconnaissance after the 2010 Earthquake are shown on this map (also depicted on the aerial view of Google Earth), and are clearly located in the immediate vicinity of the river. Figure 16 depicts the structural damage observations of the reconnaissance team.

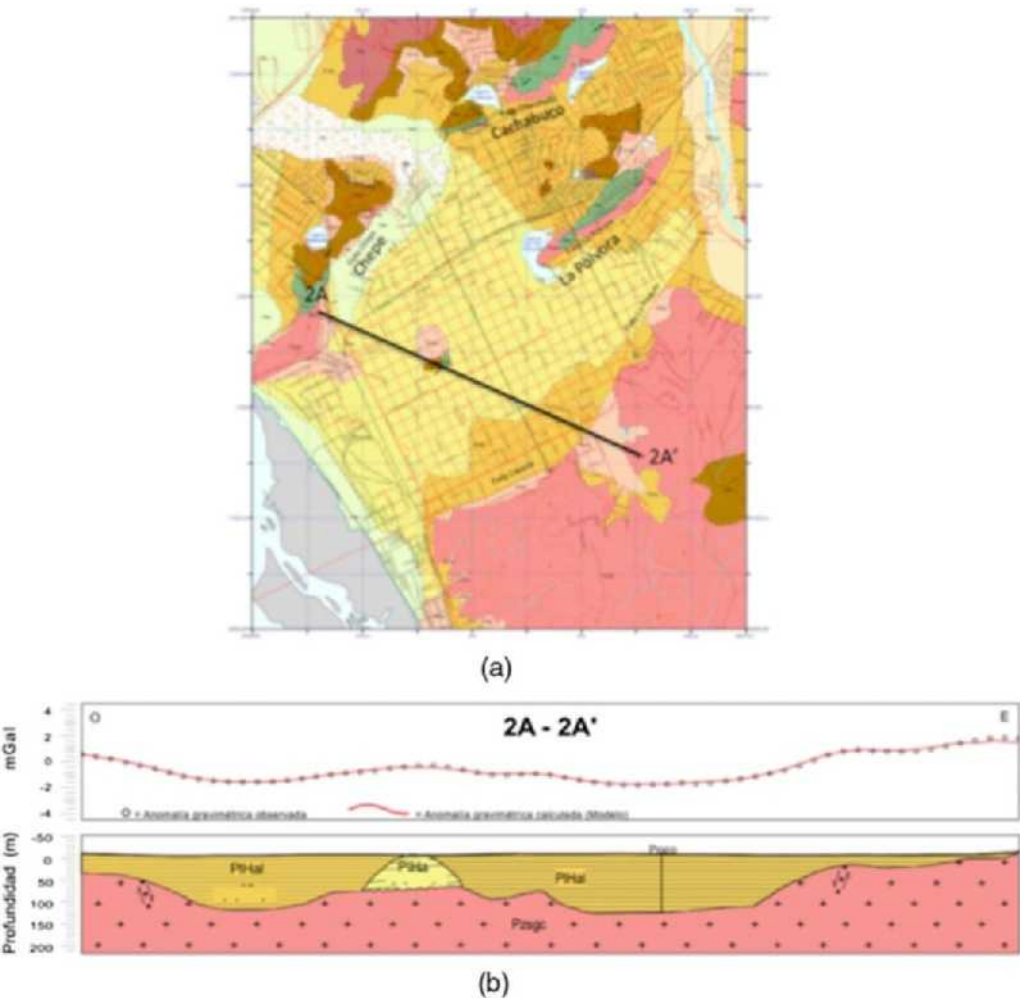
Concepción was severely hit by the earthquake of 27 February 2010, and the extensive damage in the downtown area is potentially associated with site and/or basin effects. Indeed, the damage pattern observed during the 2010 event was very similar to the distribution during the 1960 earthquake, for the most part concentrated in the downtown (Galli et al. 1963); in both events, the bridges across the Bío-Bío River collapsed. Focusing on the 2010 event, Concepción had seven distinct zones in which buildings and/or bridges collapsed catastrophically. Six of these seven zones are longitudinal in shape and oriented somehow parallel to the major faults that form the basin configuration (Figure 18). The damage is primarily correlated with the location of old lagoons that were artificially filled (non-engineered) to increase usable surface on the city (Galli, 1967), similarly to the Texcoco lake in Mexico on which Mexico city was subsequently founded; strong correlation was also noted between the thickness of the sediments and the level of structural damage (Vivallos et al. 2010). La Pólvara Fault (see Figure 19) defines the northwest edge of the south sub-basin

Figure 17. (a) Geologic map of Concepción downtown area (adapted from [Vivallos et al. 2010](#)). Red are Paleozoic granitoids, green are Upper Cretaceous sedimentary rocks, dark brownish are Paleocene sedimentary rocks, light brownish and yellow are Pliocene to Holocene sedimentary deposits that fill the Concepción basin. (b) Geological cross-section used as forward density model to fit the observed gravity anomaly.

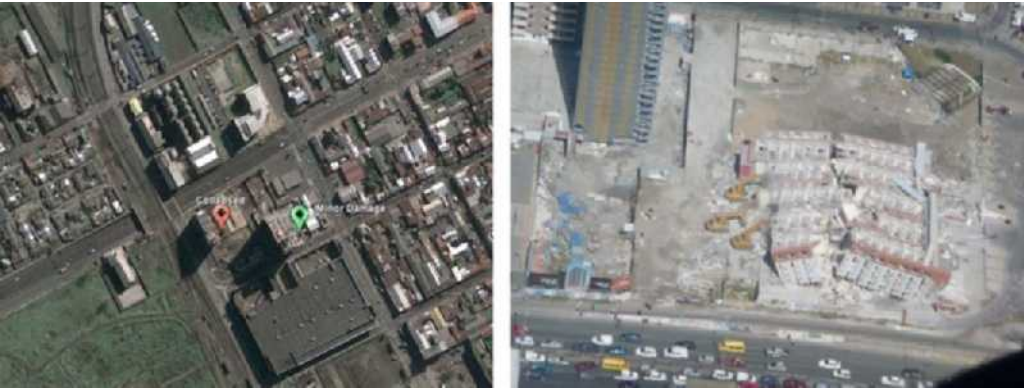
Figure 20. Locations of two adjacent buildings (see Figure 21) designed with using different site conditions and consequently different foundation types in Concepción (map and aerial view).

A striking example of the role of site conditions and soil-structure interaction in the seismic performance of structures is described below. Two adjacent multi-story structures were inspected during reconnaissance close to the Llacolén bridge in downtown Concepción (see location in Figure 19), one fully collapsed during the 2010 event and the other suffered minor damage and is currently being repaired. The 15-story collapsed building (Alto Rio) was designed using Site Type II (Chilean design code) on shallow foundation, and the one that did not collapse using Site Type III on pile foundations, which implies a higher design spectrum. While there is no evidence that the soil conditions are indeed different at the

locations of the two structures (distance between them of approximately 20 m), the difference in design spectra values may have played an important role in the failure of the building; according to the Chilean design code, the design spectral value for Type III soil conditions relative to Type II is 2.78 for period $T = 1$ s and 2.47 for period $T = 2$ s. The locations of the two buildings are depicted in Figure 20.
